**APPLICATION DATASHEET**

**Pitting & Corrosion**

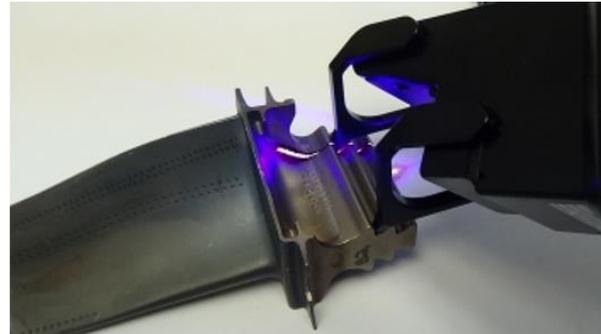
Pitting on a jet engine turbine blade requires repair once it exceeds a depth threshold. If the pitting is too severe, the blade cannot be repaired and has to be scrapped. Identifying blades that are eligible for repair saves significant costs for the airlines.

Attempts have been made to visually inspect the blades and determine the depth by comparing the pitting coloration to examples or templates. Visual measurements are not always repeatable because of the different individual capabilities of the inspectors. Optical comparators have also been used, but these machines lack the portability desired.

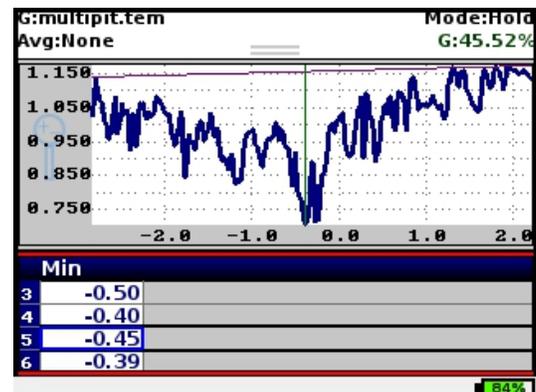
The surface profile as seen on the controller display can be captured and saved. This ASCII type file can be sent to a PC and plotted using any common spreadsheet application. Data files are of similar type and can be opened with any number of common application programs.

The operator identifies the corrosion to measure, pulls the trigger, positions the laser stripe and releases the trigger. An automatic calculation is made of the greatest depth (Min) relative to a calculated surface.
